BARBADOS WETLAND HYDRO-ECOLOGICAL DESIGN

This paper documents the biophysical process assessed in the Barbados Wetland and the ecological, morphological and hydraulic design components used to develop detailed design. This includes discussion of the design process, key elements and research outcomes that informed the final detailed design.

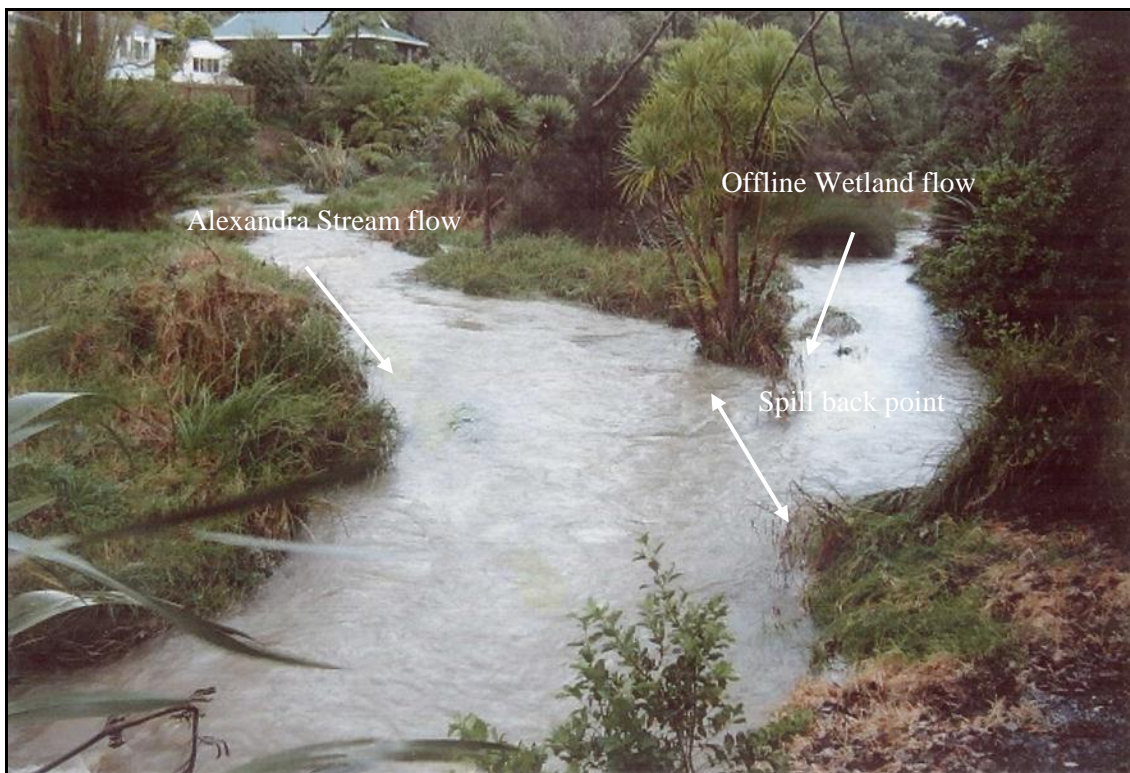
At the point of confluence both channels are open and unmodified. During low flow conditions all flows are conveyed via the main channel along the northern side of the wetland and then discharge via the Barbados Ave culvert into open channel downstream in Rook Reserve. During bankfull flows water enters the southern end of the wetland via two main paths. Firstly, the Westminister sub-catchment flows overtop its true left bank just upstream of its confluence with Alexandra Stream. Secondly, the Alexandra Stream overtops its true left bank just downstream of the confluence point with the Westminister Stream. The consequence of this is that the untreated flows from the Westminister sub-catchment have the potential to be treated before being reintroduced into the main channel in the south western end of the wetland. Figure 2 Confluence of Alexandra Stream main channel and current natural wetland area during storm event, shows the pre-construction situation in bankfull flow.

Figure 2: Confluence of Alexandra Stream main channel and current natural wetland area during storm event (photo taken by local resident Nicholas Mayne)

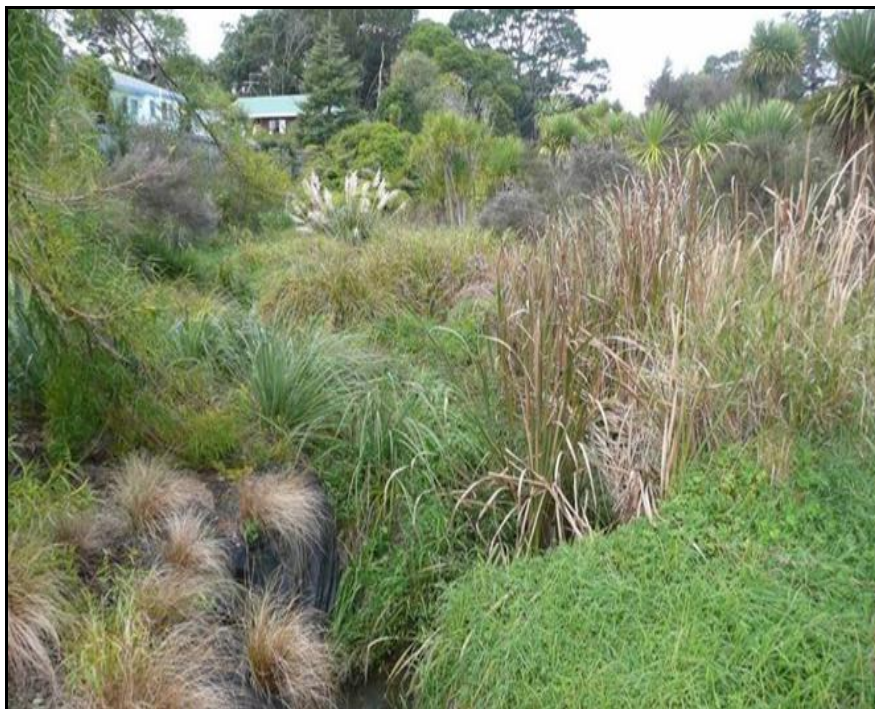
A Stream Ecological Valuation (SEV) assessment was carried out on 29th May 2009 (see Rook Reserve & Barbados Wetland SEV Report, Morphum Environmental Ltd, 2009). Macroinvertebrate samples were collected following Protocol C2 (Stark et al., 2001) and processed in the laboratory. Fish data was collated from previous studies, the NIWA Freshwater Fish Database (NZFFD) and through net-fishing carried out during the assessment (Refer Figure 4).

Figure 4: Main stream channel and SEV site location

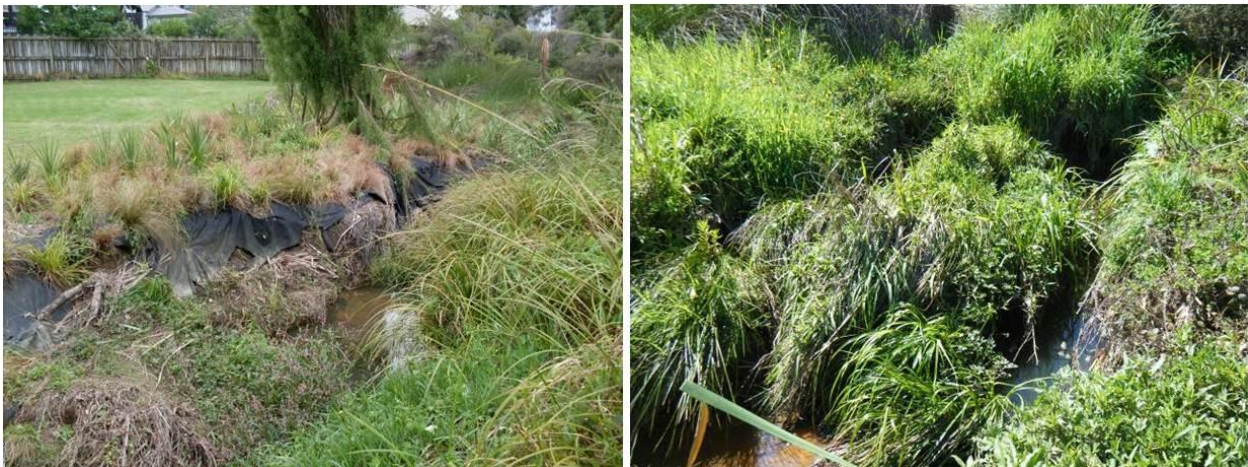
An attempt has been made in recent years to stabilise the banks using a geotextile layer and planted grasses (through council supported local community action). However, this has proved unsuccessful with slumping and benching into the main channel being observed ongoing. This has been reducing the cross section of the channel and the flow area, resulting in reduced instream habitat quality and amenity value, as well as presenting a health and safety risk for the public using the reserve for recreation (refer Figure 5).

Figure 5: Showing previous attempts to arrest bank slumping and the reduction in channel cross-sectional area

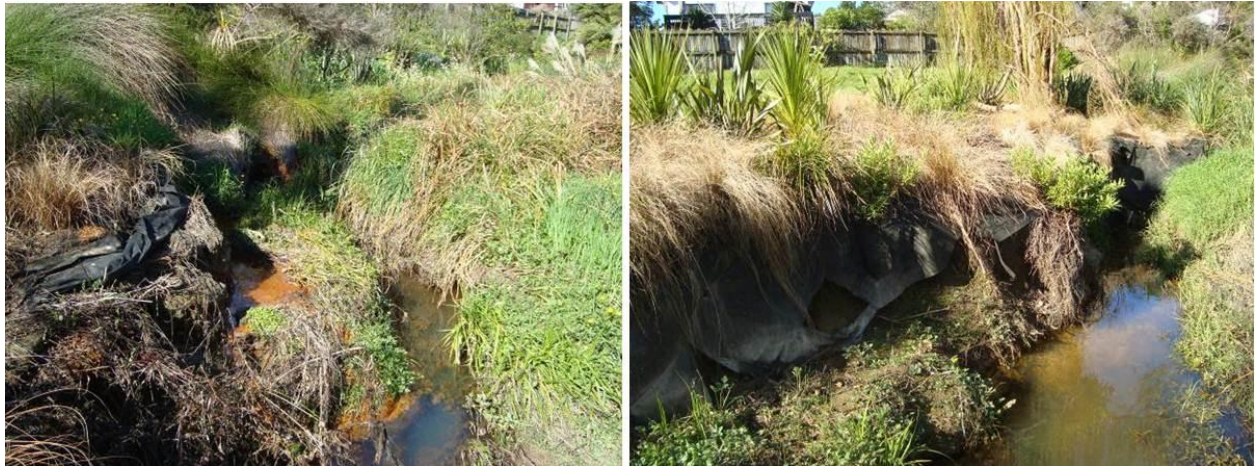
The continual and ongoing slumping had resulted in a shifting and unstable substrate with lowered water depths. The effects of this being reduced macroinvertebrate habitat quality and the movement of mobile sediments to reaches downstream.

Figure 6: Showing previous attempts to arrest bank slumping

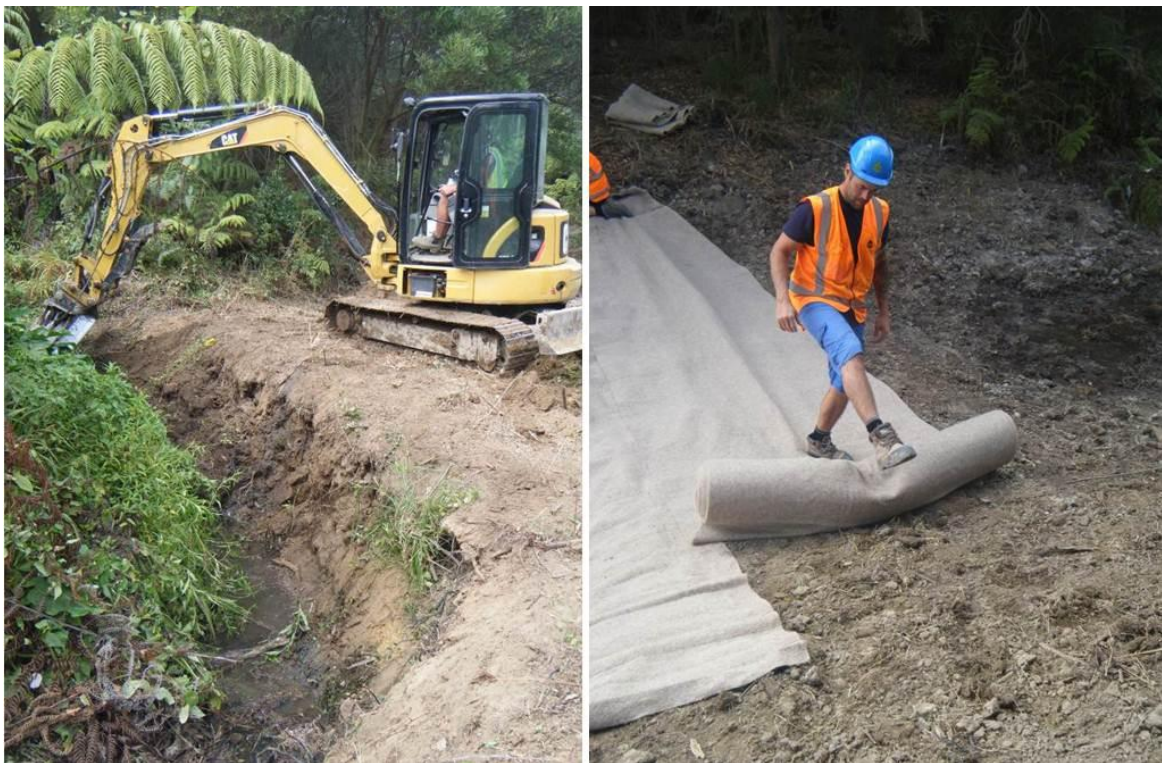
The works to arrest and mitigate bank slumping involved cutting back the existing bank material to a slope at which the soil is was stable at around 1 in 3 generally. This increased the cross sectional width of the stream and would include the installation of point bars and rock riffles to dissipate some of the erosive energy of the stream reducing ongoing erosion.

Figure 7: Showing battering of the banks the laying of geotextile cloth for planting

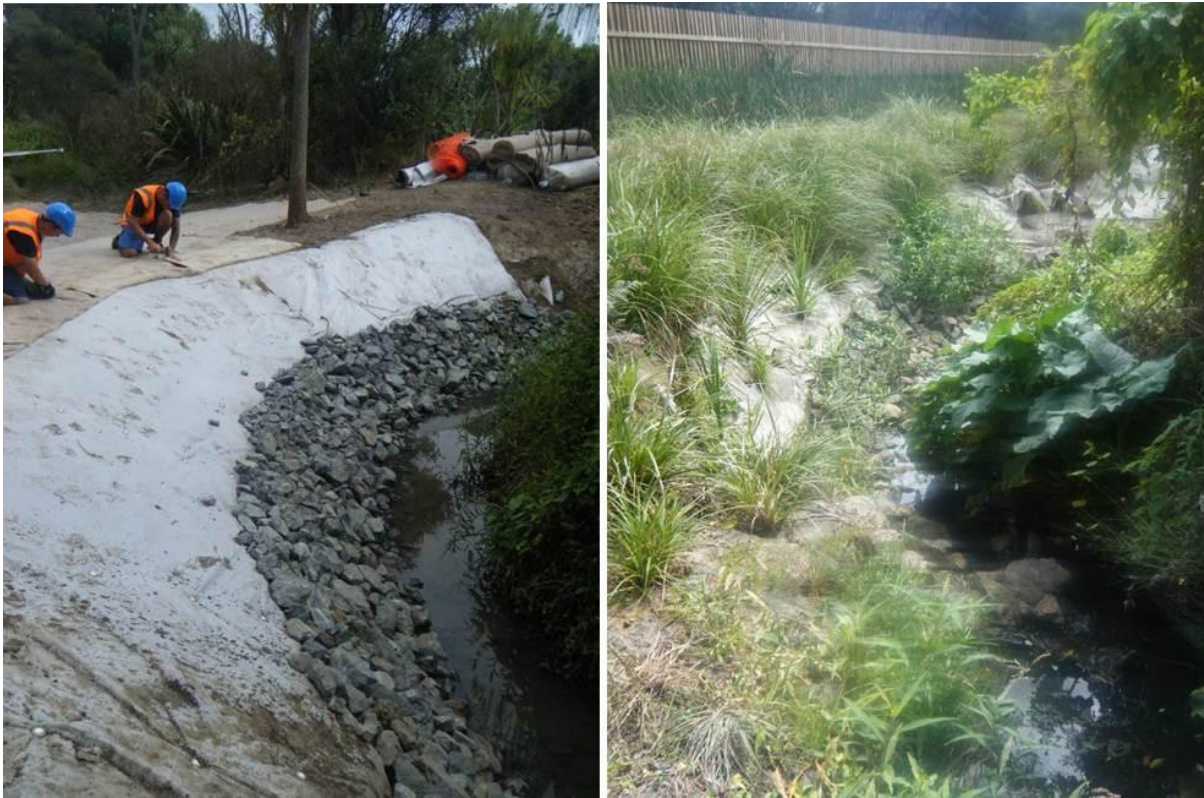
Bank and toe protection measures included rock lining of the toe, geotechnical fabric pinned and closely spaced planting for future biological stability enhancement. This has resulted in increased habitat value of the stream through improving habitat complexity and heterogeneity. This is particularly relevant when point bars are used in conjunction with designed riffle features to create a varying depth profile of pools and the aerating effects of the rock riffles which increased the function of the stream to support fish and other aquatic organisms. Revegetation of the stream banks has improved overhead cover

Figure 8: Showing toe armoring and planting after 6 months

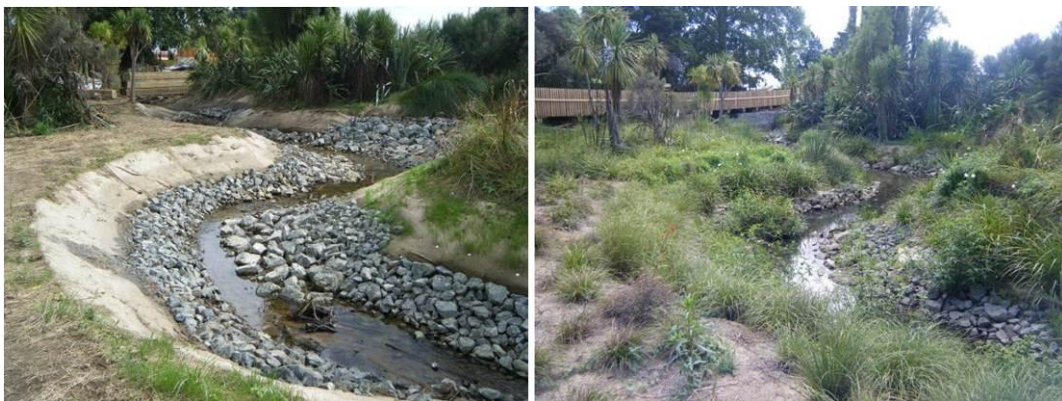
Pool, riffle run sequences are important geomorphic and ecology features of a habitat diverse natural stream system. In this instance the design has had to mimic nature through channel design and substrate placement. Figure 9 shows this partially through the works and 6 months after. The design was based on the existing pool run sequence and directly reflects the pre works hydraulics in this regards. The maximum pool depths targeted to 500mm and small point bars used to create riffles and increase substrate heterogeneity. The minimum run depths being 50mm but this understandably depends on baseflow regime.

Figure 9: Showing bank and bed modifications through pool and run sequences

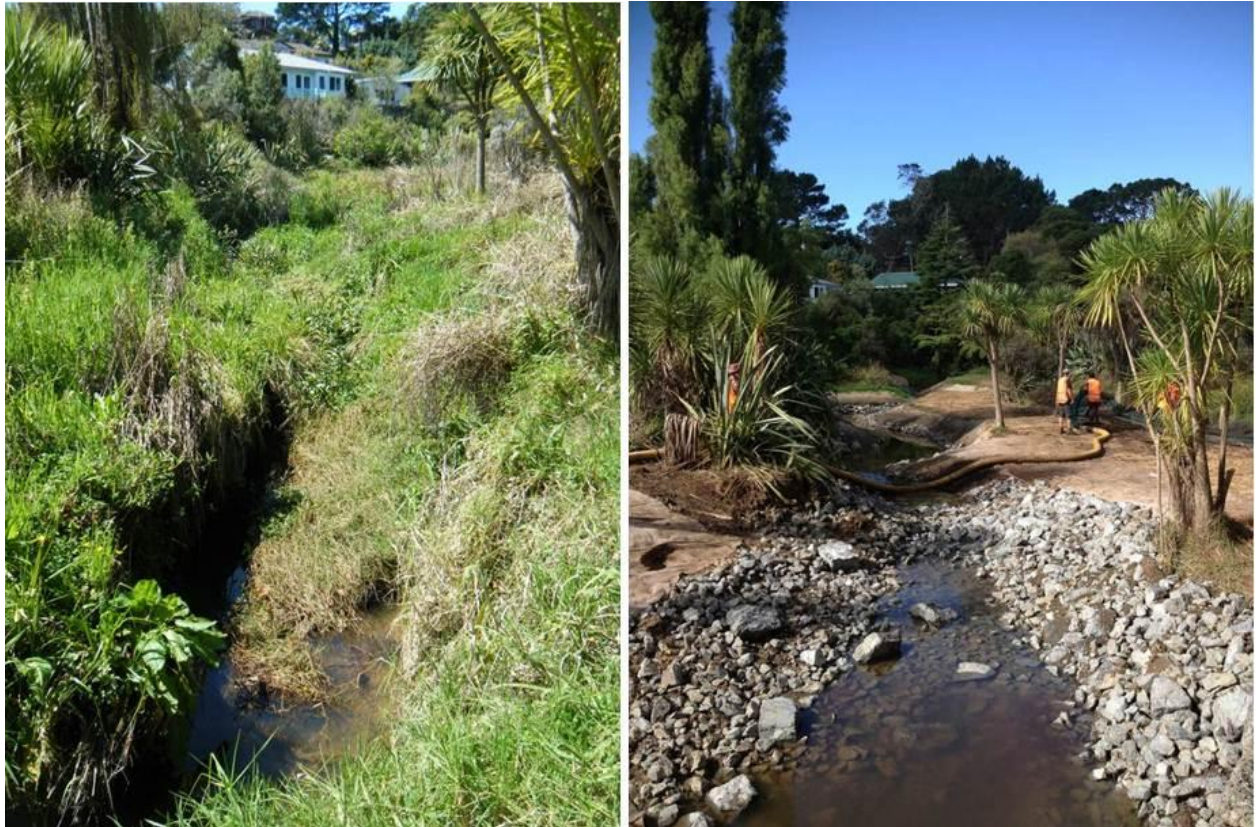
Figure 11: Rock Riffle pre and immediately after works

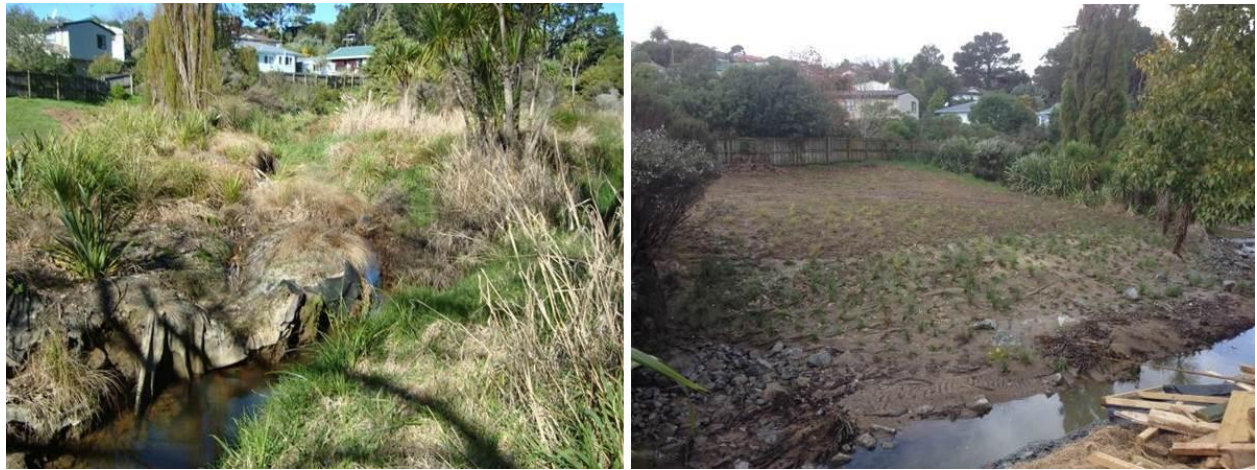
The works resulted in a dramatic transformation of banks that had been slumping and unstable with high flows rushing toward the culvert entrance, to a stable widened section creating an eddy, capturing sediment and reducing peak flow velocities (refer Figure 13).

Figure 13: Shows before and after point bar construction

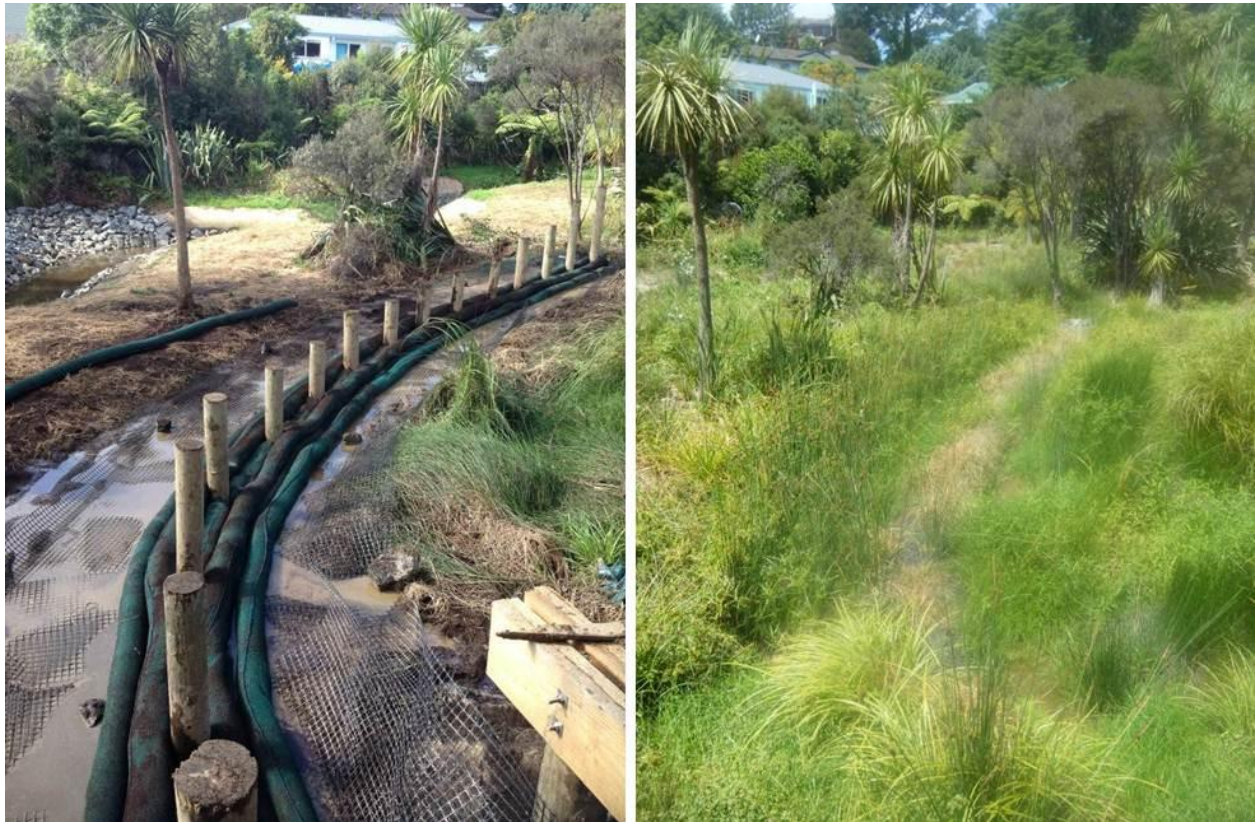
Figure 15: Weeping Wall Bund During and 6 Months After Construction

One of the main aims in the design and construction of this element was for it to blend into the environment. Even after 6 months this has begun to occur with seed stock from the remnant wetland plant assemblages beginning to take hold and spout through the geotextile (refer Figure 15).

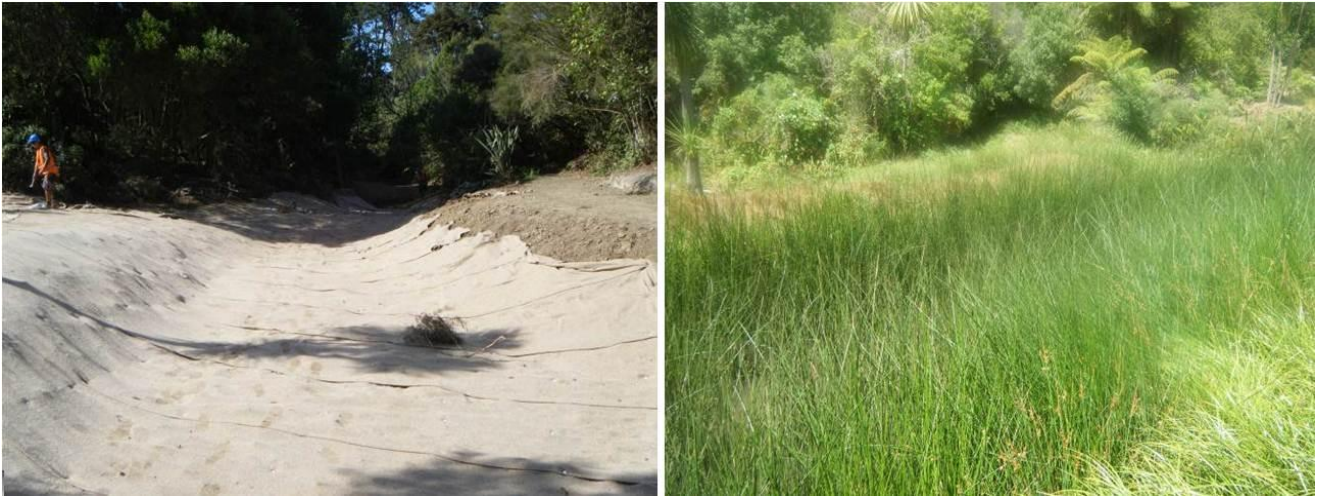
The final design included two depression areas separated by a low earth bund which were lined with geotextile and planted with wetland species. This has acted to increase the conveyance capacity which provides flows to the ephemeral wetland and has provided deep water wetland habitat with associated storage that recharges the downstream reach with treated waters that augment low summer base flows (refer Figure 16).

Figure 16: Improved conveyance channel and constructed depression wetland

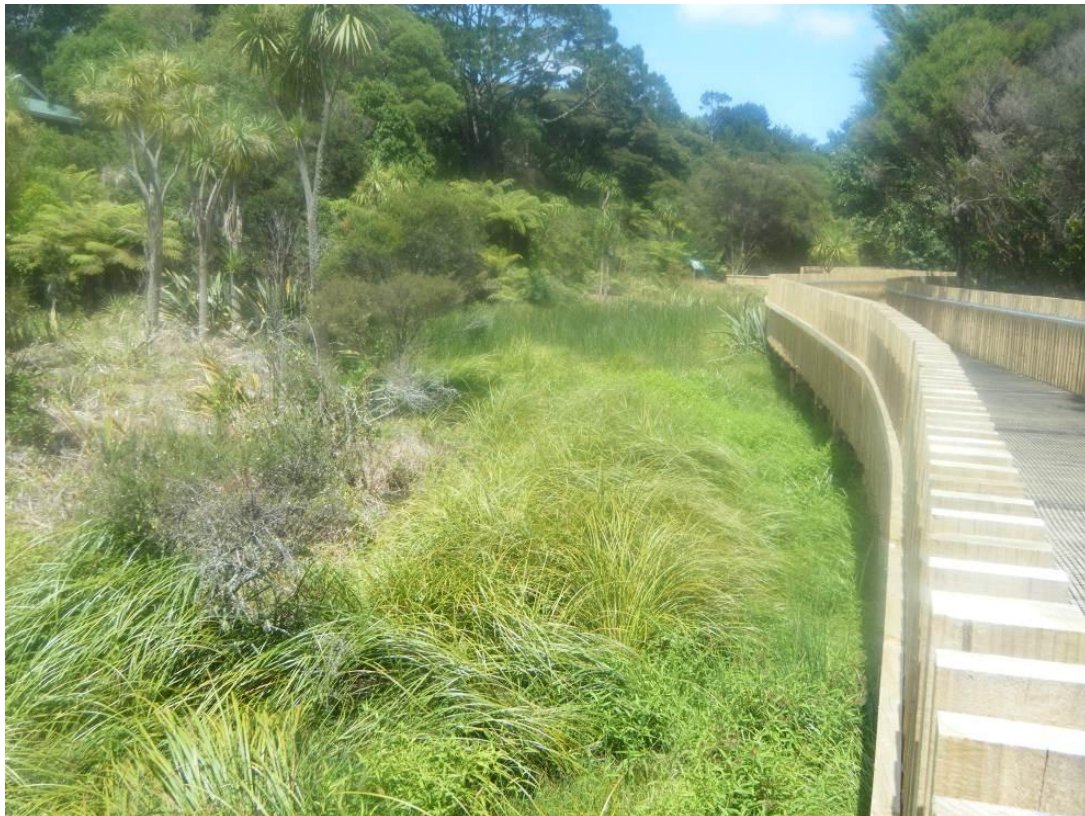
The replacement of a weed infested wetland with eroded and unstable banks, with a system now enhanced in habitat value and structural resilience, is a positive outcome from the project. The design integrated a proposed cycleway and created a high value amenity feature (refer Figure 17).

Figure 17: The finished works looking along the new Cycleway

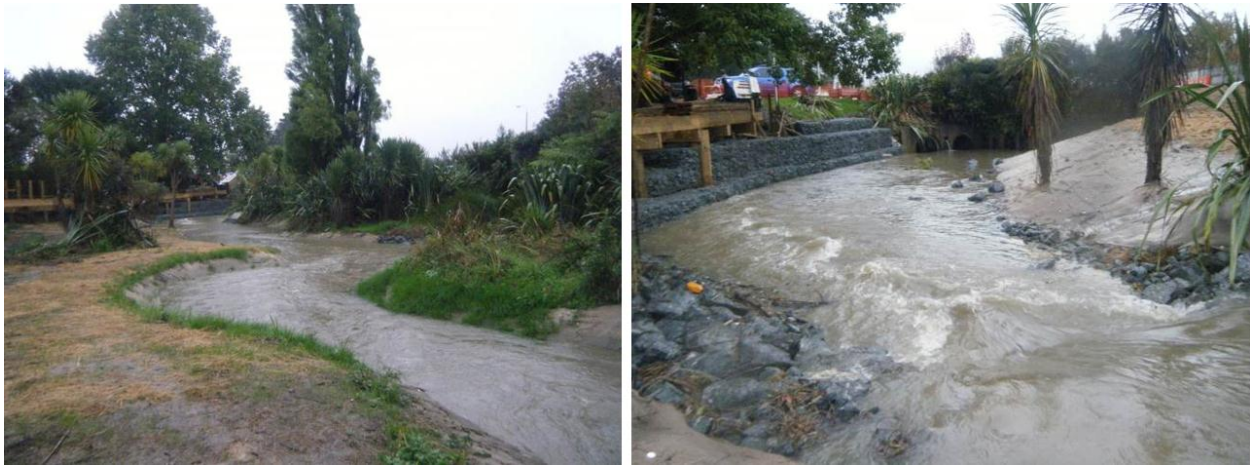
Critical to the success of channel modification and erosion protection works is how they are able to withstand the force of erosive flows. During final construction phases the site experienced approximately annual peak flows and responded well (Figure 18).

Figure 18: Showing flood flows during final stages of site works
